Screening Site Inspection Report

D.M. Fertilizer, Inc.

USEPA ID No. ILD 087 157 947

September 15, 1995

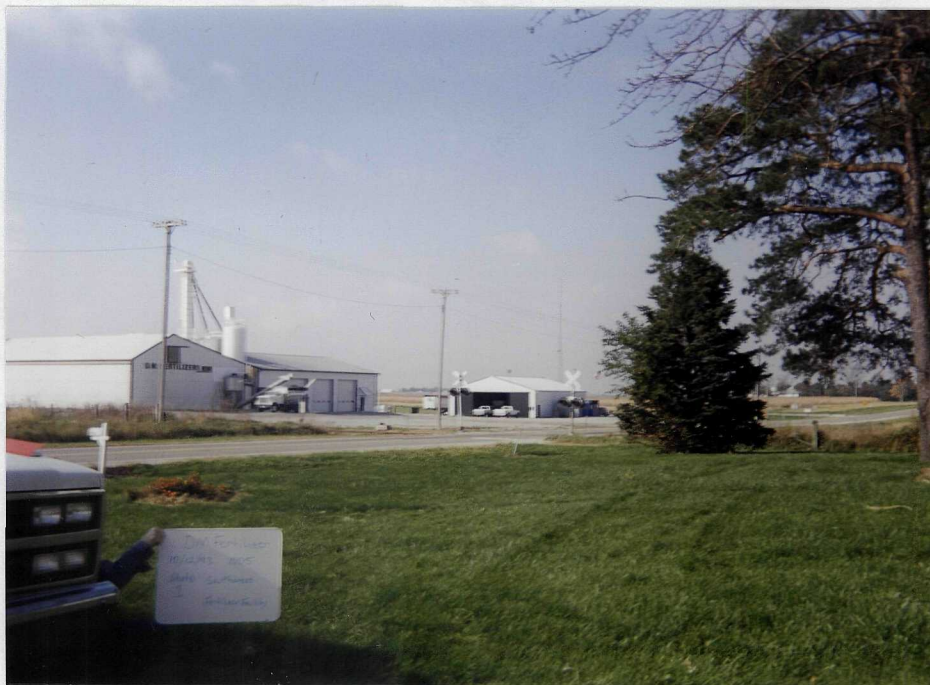
Site: DM Fertilizer
 Proj. #: 70970.101
 Roll: 1 Photo #: 1
 Date: 10/12/93 Time: 1005
 Photographer: S. Mehay
 Description: Northeastern side of DM Fertilizer, as seen from the nearest private residence. The residence is about 400 feet northeast of the site.

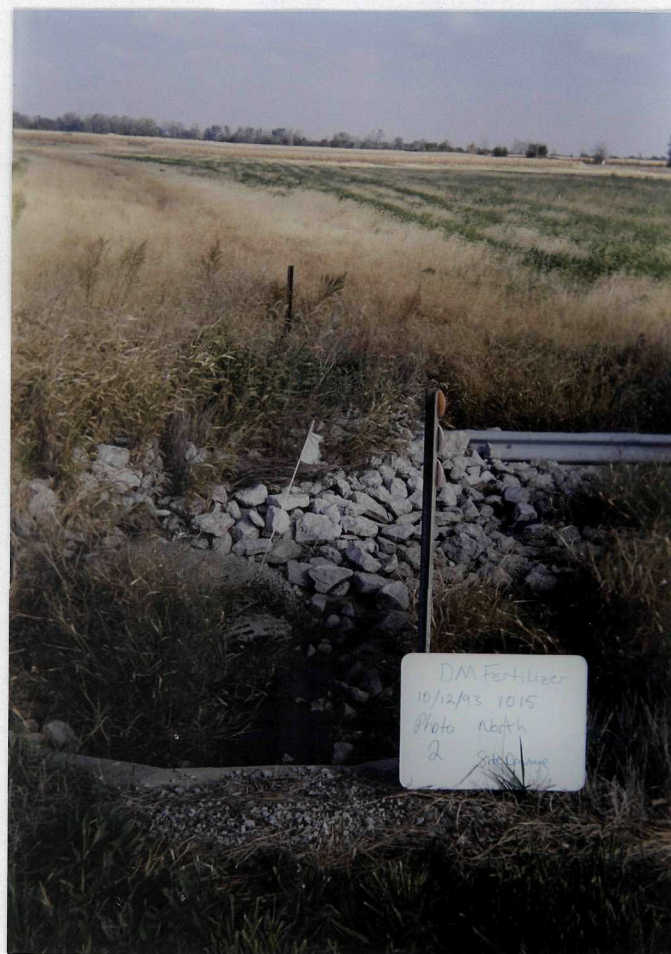
The overland flow route to the North Fork Vermilion River is poorly defined. Site runoff appears to be captured by ditches on the western and northern sides of the site. Runoff in these ditches flows north, through a reinforced concrete box under Route 9 to a grated drain in the ditch on the northern side of Route 9. The

drain is shown in photographs number 2 and 3 in Appendix B. The outfall location for this drain was not determined during this SSI. When runoff exceeds the drains capacity, overflow will spill over a small rock berm in the fence line on the northern side of the Route 9 ditch, and flow over cultivated farm ground north and then northwest to the river. No channel was observed to be eroded into the farm ground. The probable point of entry into the river is about one-half mile northwest of the site.

Site: DM Fertilizer
 Proj. #: 70970.101
 Roll: 1 Photo #: 2
 Date: 10/12/93 Time: 1015
 Photographer: S. Mehay
 Description: Ditch at northern end of the reinforced concrete box under Route 9. Beyond the rock berm in the fence line, overland flow is through the grass covered field in the background. Note drain at the base of the white flag. View is to the north.

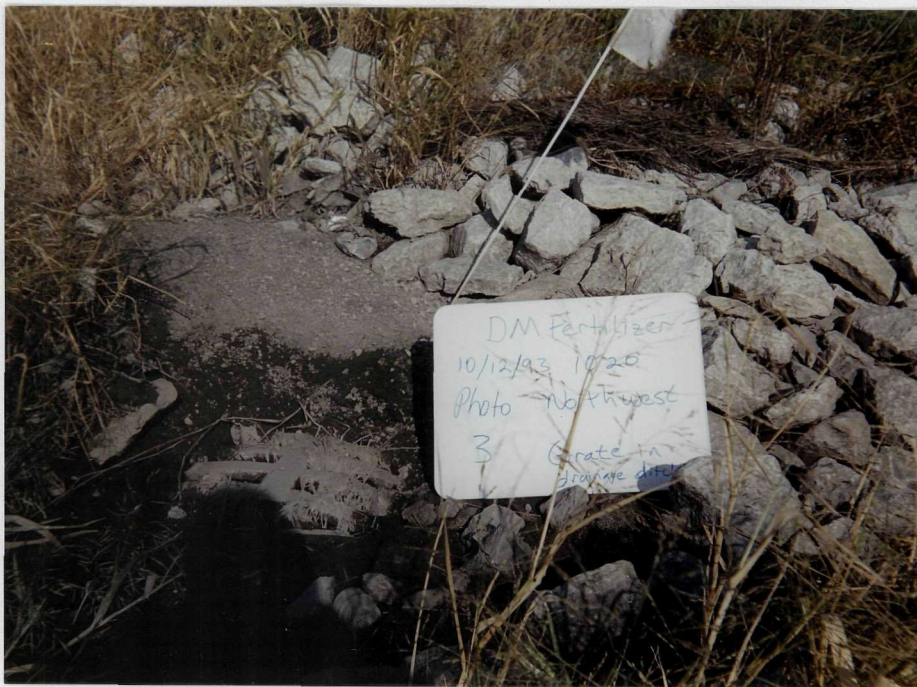
Site: DM Fertilizer
Proj. #: 70970.101
Roll: 1 Photo #: 3
Date: 10/12/93 Time: 1020
Photographer: S. Mehay
Description: Close up of drain in ditch on
north side of Route 9. View is to the
northeast.
